# RVi Example Inspection Report

**CUSTOMER**  
Jordan Whitfield

**INSPECTION DATE**  
Jun 10, 2026

**MODEL**  
Navion 24G

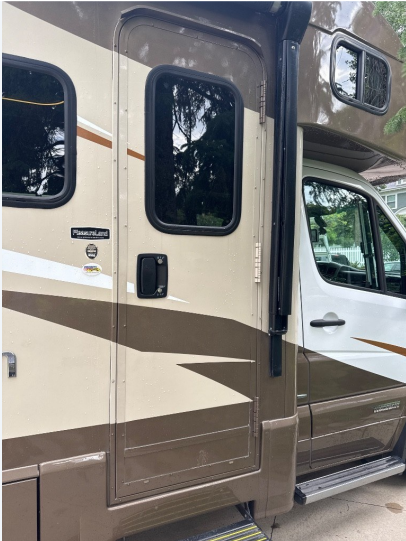
**Notes:** The latch on the screen door catches on the strike plate when opening and closing the door. It is recommended this be further evaluated by a qualified RV technician.

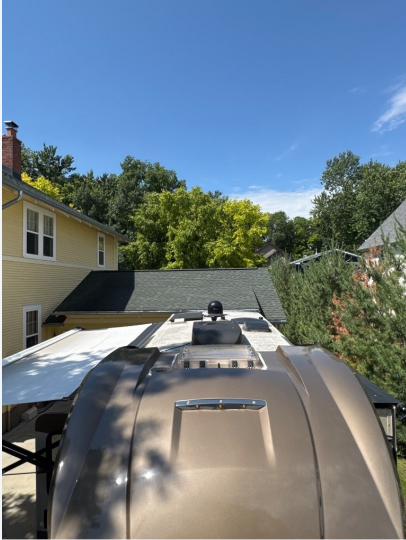
Front to Back

**Notes:** There is evidence of a recent re-seal of the roof. This was done by applying lap seal over the existing sealant. While a satisfactory repair, the bulk of the sealant appears to be factory original and in generally good shape. It is recommended sealant be examined regularly due to age. There are breaks or cracks in the rear cap top trim approximately in the center of the unit. This has been partially sealed however cracks still exist that could allow water intrusion. It is recommended this be further evaluated by a qualified RV technician.

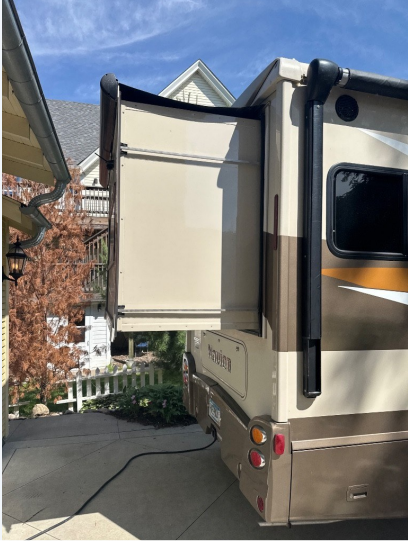
**Notes:** The bulb seal on the curbside (passenger) vertical is damaged by the slide mechanism and pulled away from the wall at the top. This increases opportunity for whater intrusion. It is recommended this be further evaluated by a qualified RV technician.

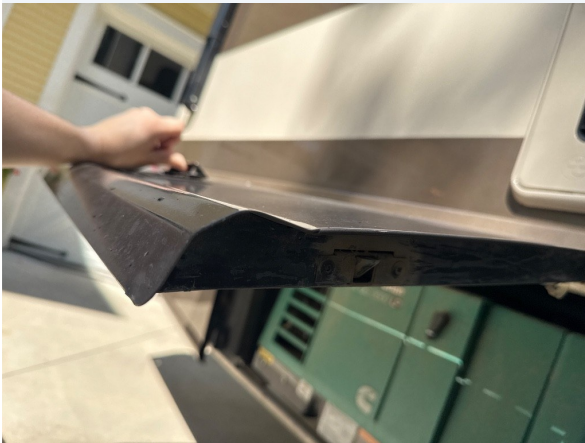
**Notes:** Generator compartment latch is sticky. Curbside front storage difficult to close. It is recommended this be further evaluated by a qualified RV technician.

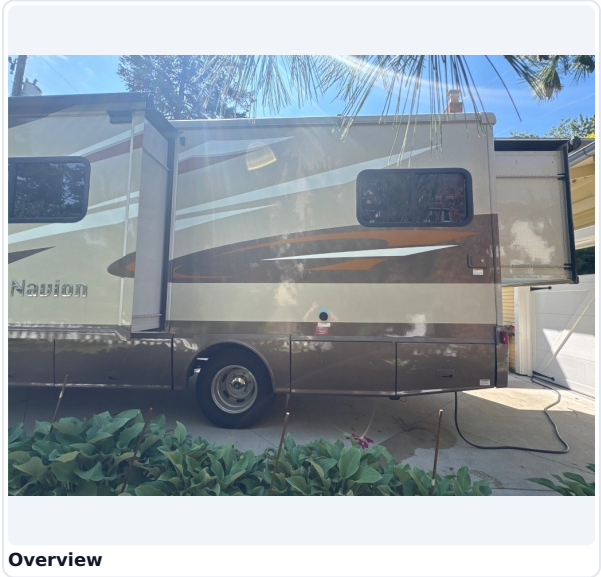
**Notes:** The sidewalls are in excellent condition. There is some minor cracking / weathering in the sealant along some joints that should be monitored for further degradation. It is recommended this be further evaluated by a qualified RV technician.

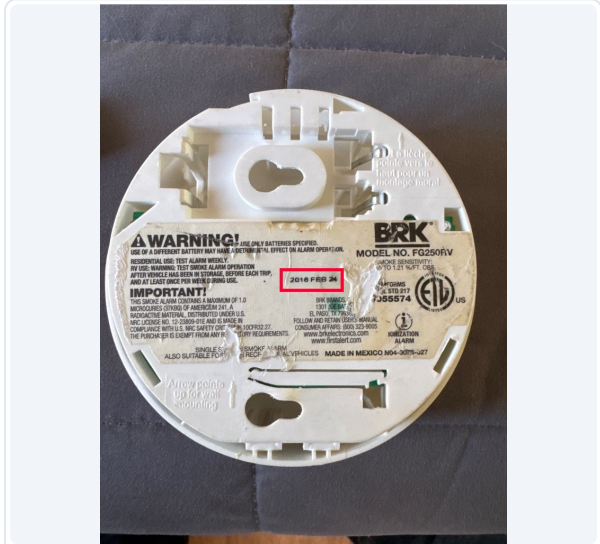
Bedroom Smoke Detector

POOR    LIFE SAFETY    MINOR ISSUE

**Notes:** The unit is at end of life. It is recommended smoke detectors be replaced within 8 years of manufacture date. Battery appears to be dead.

Manufacture Date: 2108 Feb 24

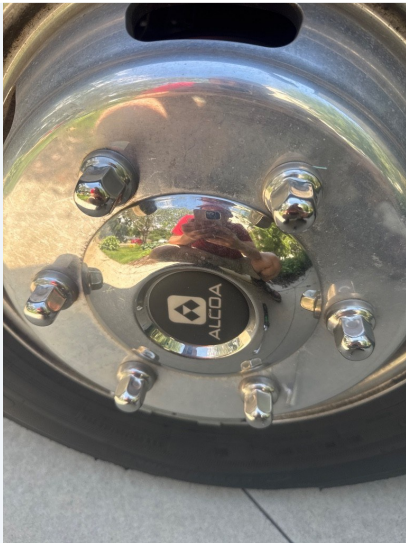
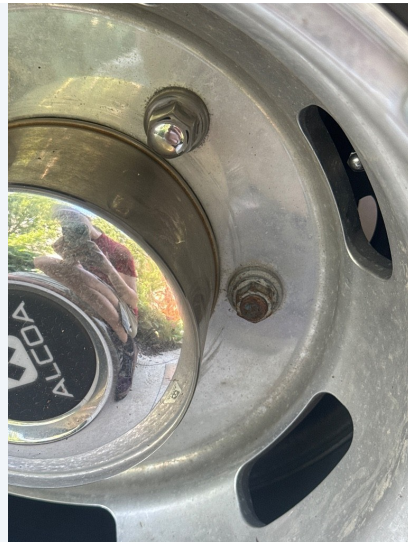
**Notes:** rear streetside outer tire lug nut is missing cap and rusted

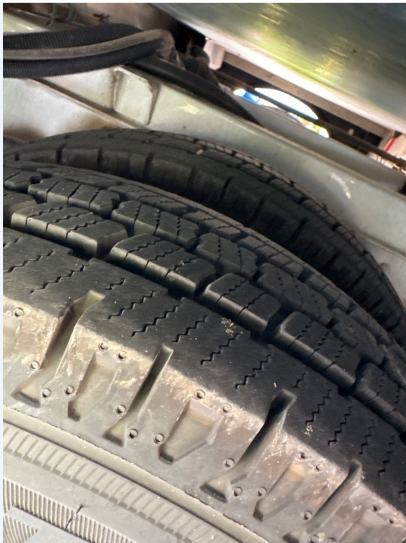
**Notes:** all tires are below recommended pressure (61psi)

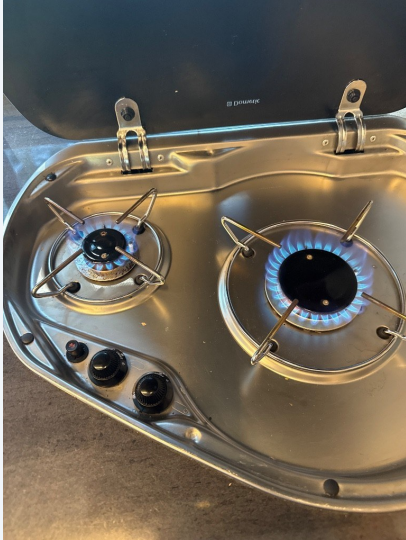
Cooktop Operating

**Notes:** Normal flame color. Ignitor worked on both burners. Note that you must press the gas knob down to ignite - then release and set to desired flame height.

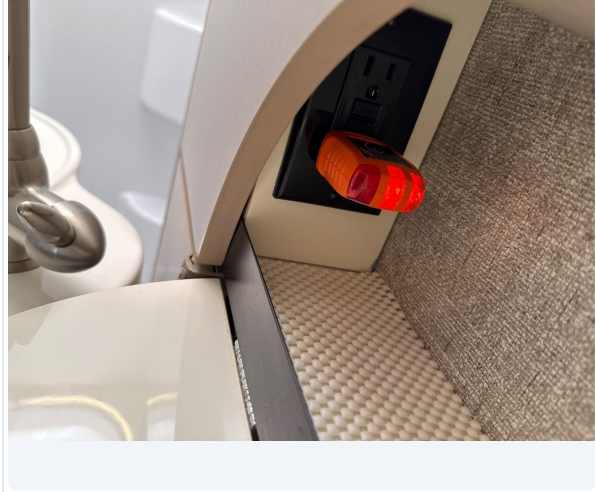
**Bathroom**

Hard to press gfci reset but it does work and the test passed

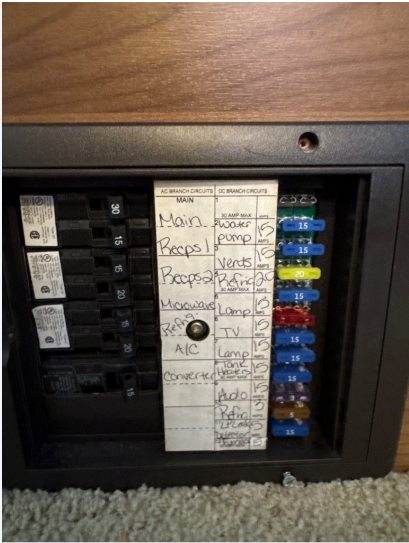
Inside Panel Box

Notes: Ground wire loose

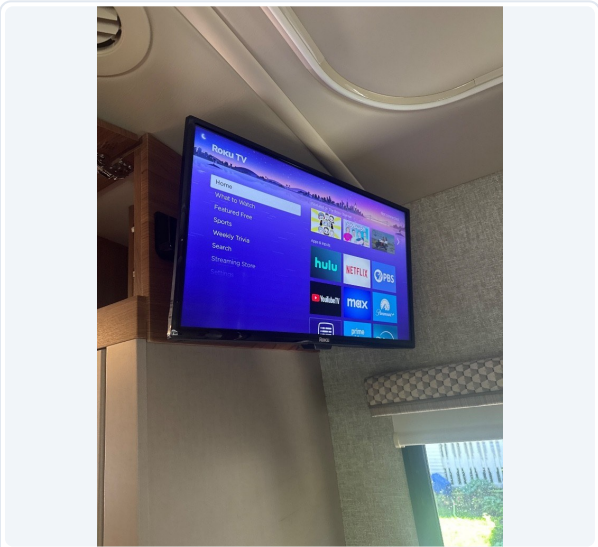
**Notes:** Television has been upgraded to an aftermarket smart TV.

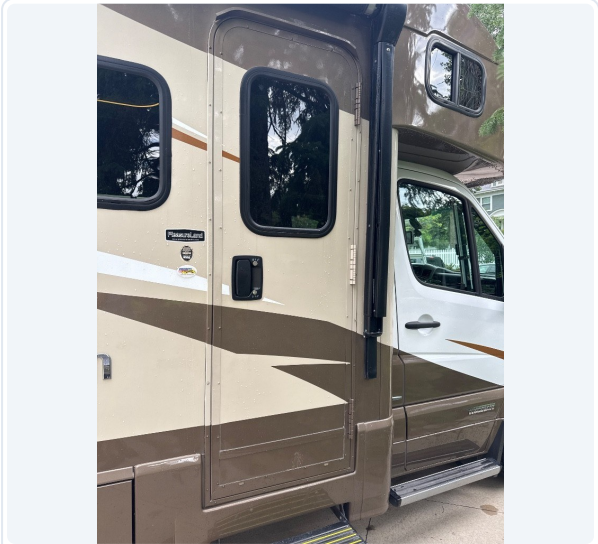
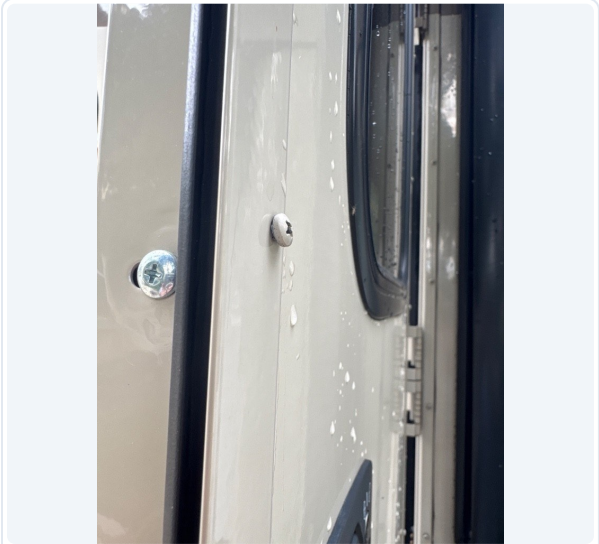
**Notes:** The latch on the screen door catches on the strike plate when opening and closing the door. It is recommended this be further evaluated by a qualified RV technician.

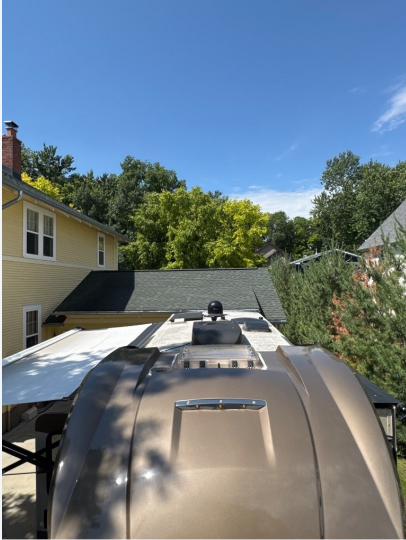
Front to Back

**Notes:** There is evidence of a recent re-seal of the roof. This was done by applying lap seal over the existing sealant. While a satisfactory repair, the bulk of the sealant appears to be factory original and in generally good shape. It is recommended sealant be examined regularly due to age. There are breaks or cracks in the rear cap top trim approximately in the center of the unit. This has been partially sealed however cracks still exist that could allow water intrusion. It is recommended this be further evaluated by a qualified RV technician.

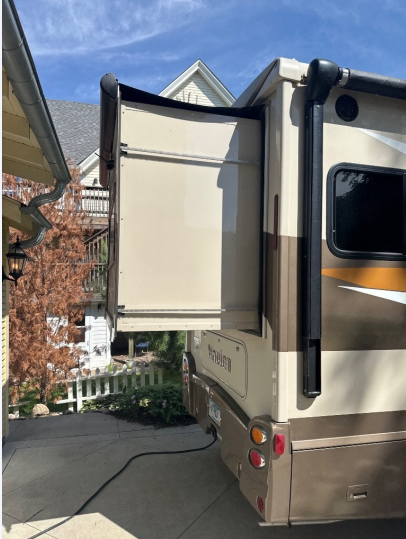
**Notes:** The bulb seal on the curbside (passenger) vertical is damaged by the slide mechanism and pulled away from the wall at the top. This increases opportunity for whater intrusion. It is recommended this be further evaluated by a qualified RV technician.

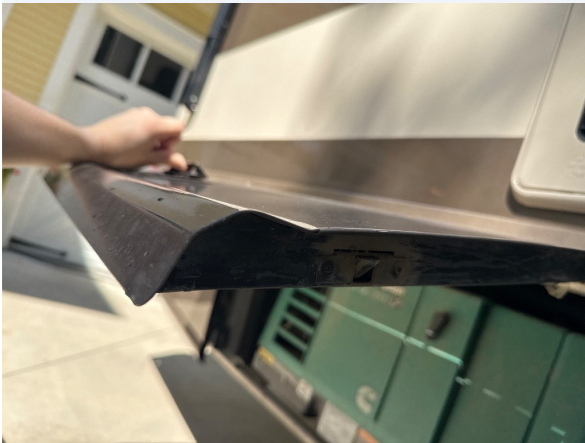
**Notes:** Generator compartment latch is sticky. Curbside front storage difficult to close. It is recommended this be further evaluated by a qualified RV technician.

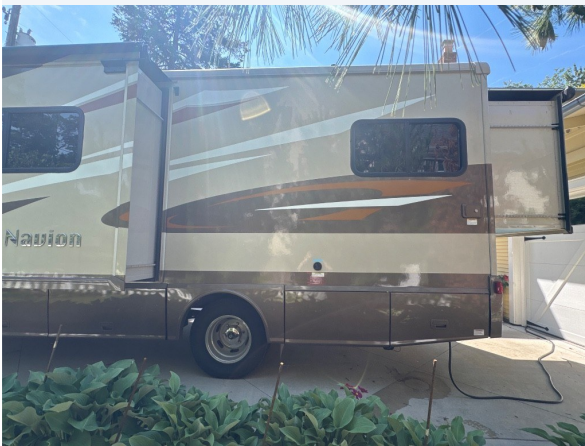
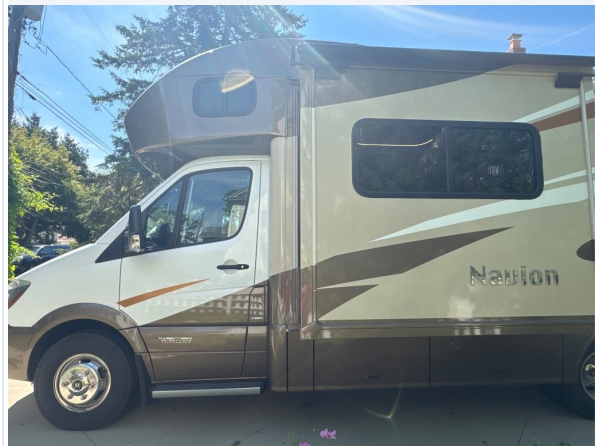
**Notes:** The sidewalls are in excellent condition. There is some minor cracking / weathering in the sealant along some joints that should be monitored for further degradation. It is recommended this be further evaluated by a qualified RV technician.

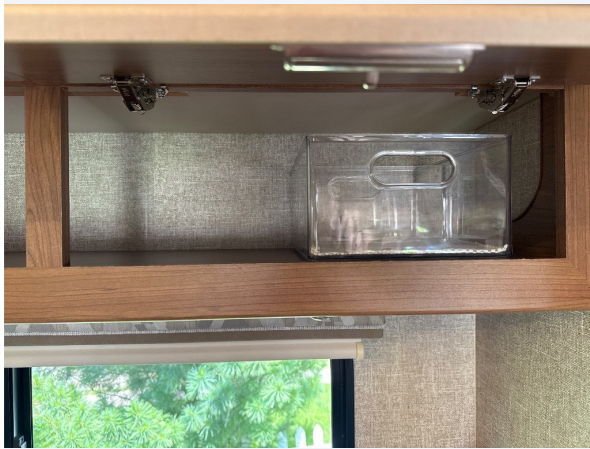
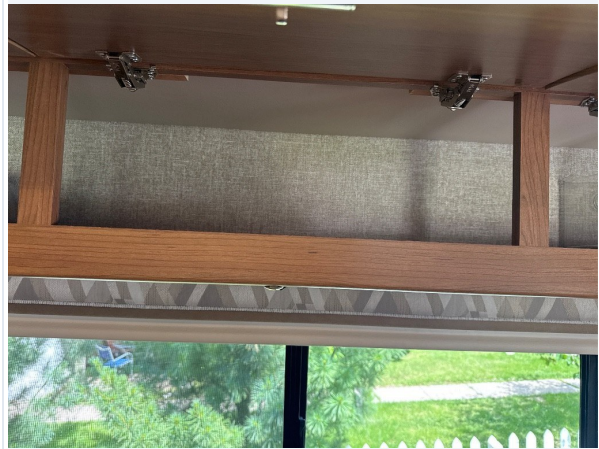
**Notes:** cabinet handle by sink loose. cabinet above fridge doesn't close flush
